# MEASUREMENT REPORT

## CRANKSHAFT

### After grinding

Engine type : **Crankshaft Mak 6M453AK**

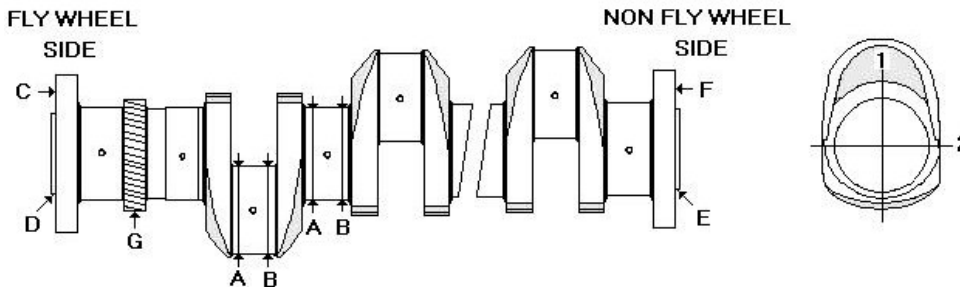
### Mainjournal and crankpin dimensions Measurement deviation 0.01 mm

Nominal dimension :	244,00 mm								Mainjournal				Standard dimension :				245,00 mm			
	1	2	3	4	5	6	7	8	9	10	11	12	9	10	11	12	9	10	11	12
<b>A</b> Position 1	-1	-1½	-2	-1	-2	-1½	-2½	-2												
Position 2	-1½	-1½	-2½	-1½	-1½	-1½	-2½	-2½												
<b>B</b> Position 1	-1	-1	-2	-2	-1½	-2	-2½	-2												
Position 2	-1	-1½	-2½	-1½	-1	-2	-2½	-2½												
Cracks found	NO	NO	NO	NO	NO	NO	NO	NO

Nominal dimension :	244,00 mm						Crankpins						Standard dimension :						245,00 mm					
	1	2	3	4	5	6	7	8	9	10	11	12	9	10	11	12	9	10	11	12				
<b>A</b> Position 1	-1	-1	-2	-1½	-1	-1½																		
Position 2	-1½	-1	-3	-2	-1½	-2																		
<b>B</b> Position 1	-1	-1½	-2½	-1½	-1	-1½																		
Position 2	-1½	-1	-3	-2½	-1½	-2																		
Cracks found	NO	NO	NO	NO	NO	NO

Remarks : **all mainjournals and crankpins are 1,0 mm undersize.**
